ANALYSIS OF THE HYDROLOGIC, HYDRAULIC AND
_____ GEOMORPHIC ATTRIBUTES OF THE
YOSEMITE VALLEY FLOOD: JANUARY 1-3, 1997

Technical Report NPS/NRWRD/NRTR-97/129

July 1997

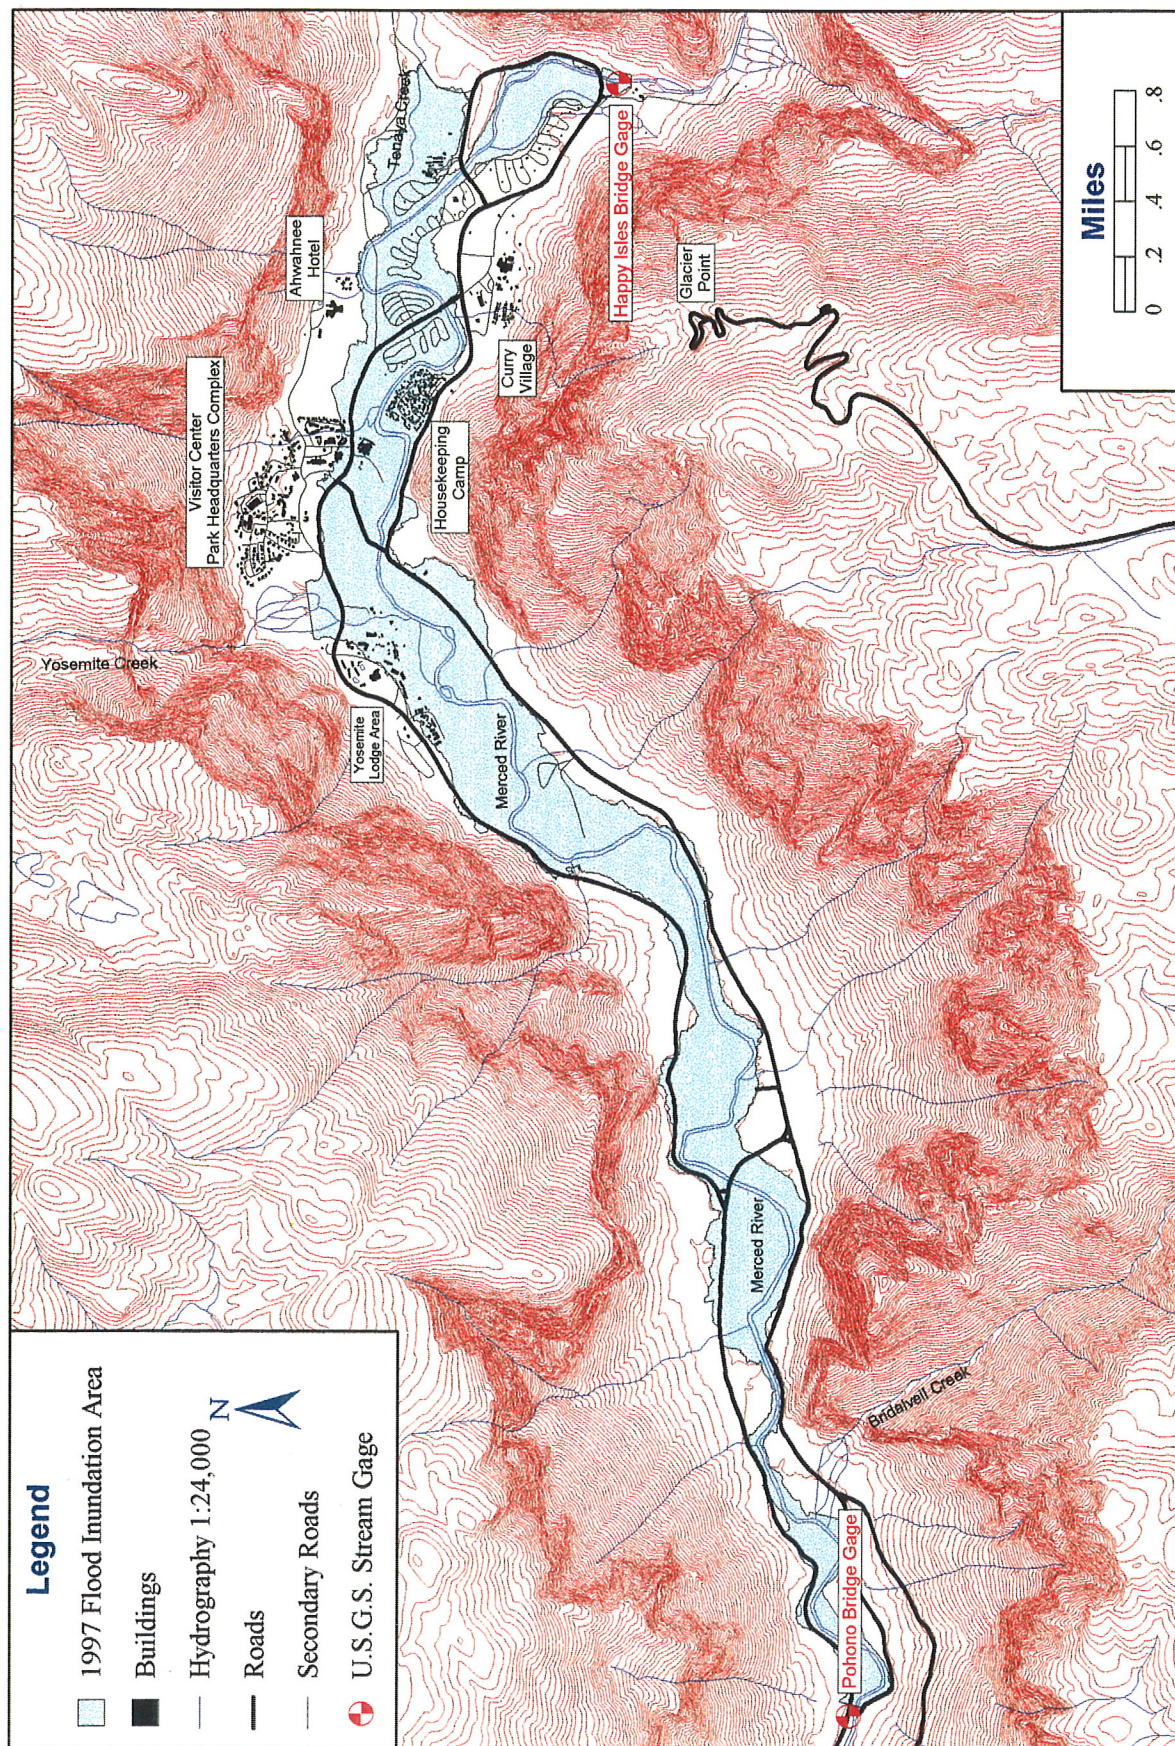
FIGURE 1. MAP OF YOSEMITE VALLEY SHOWING THE LOCATIONS OF THE HAPPY ISLES AND POHONO STREAMGAGES AND THE APPROXIMATE 1997 FLOOD INUNDATION AREA.

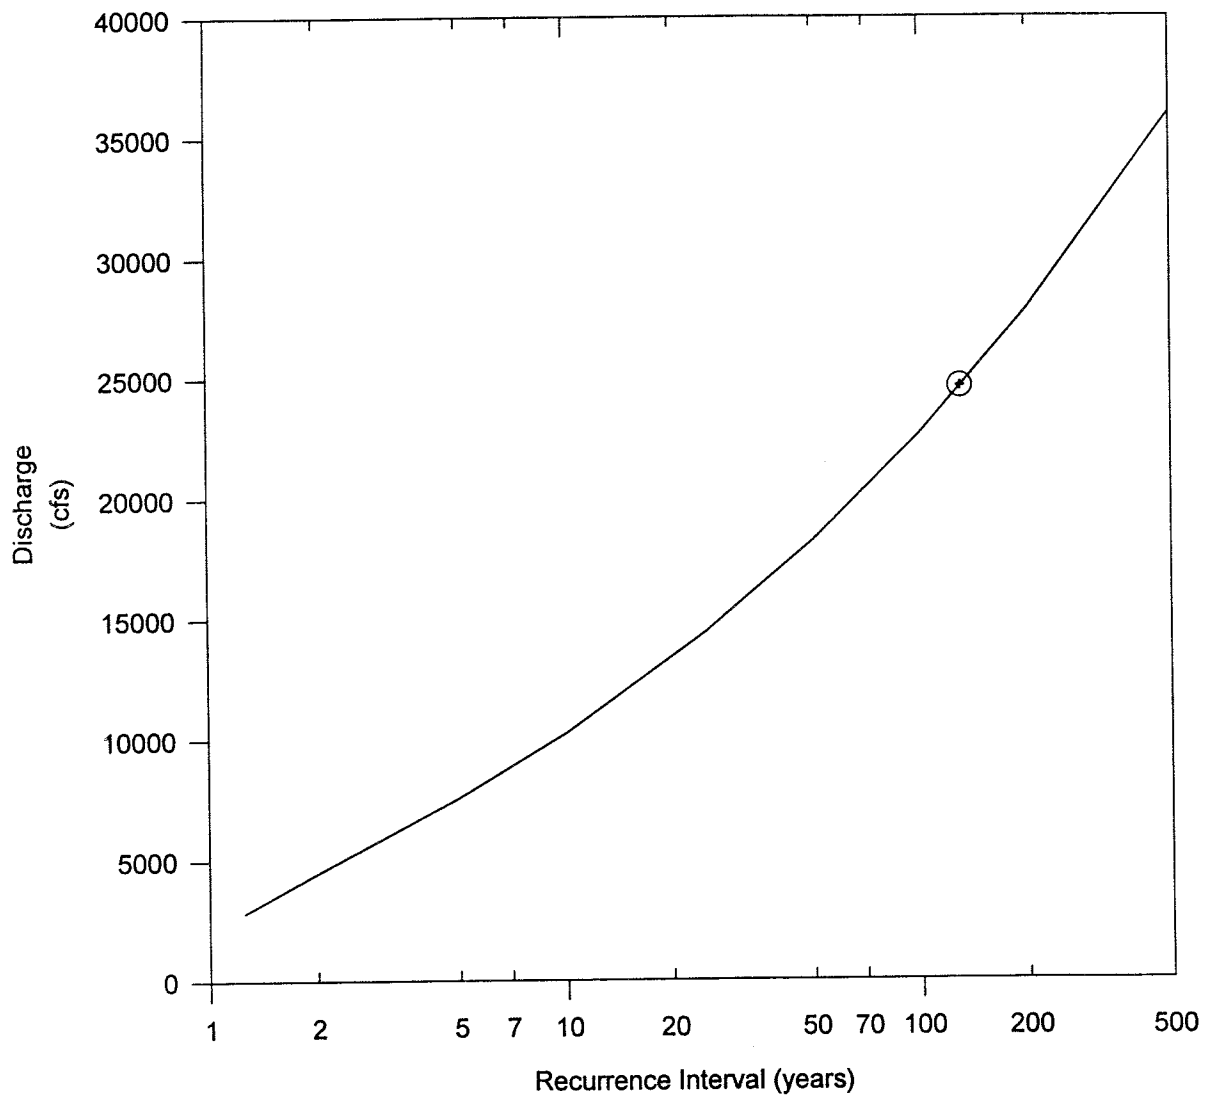
A log-Pearson Type III frequency distribution was fitted to the annual peak series at the Pohono stream gage for the record from 1917 to 1996. Based upon this analysis, a flood of the magnitude experienced on January 2 or 3, 1997, is estimated to be slightly larger than the one-percent-chance-flood (100-year flood) for the Merced River at Pohono Bridge. The estimated flood frequency relationship for this gage derived from the log-Pearson analysis is shown in Figure 3.

Figure 3. Flood frequency relationship for Merced River at Pohono Bridge stream gage, showing magnitude of the January 1997 flood. Frequency curves computed by log-Pearson III analysis of annual peak flow series for period of record (exclusive of 1997) .

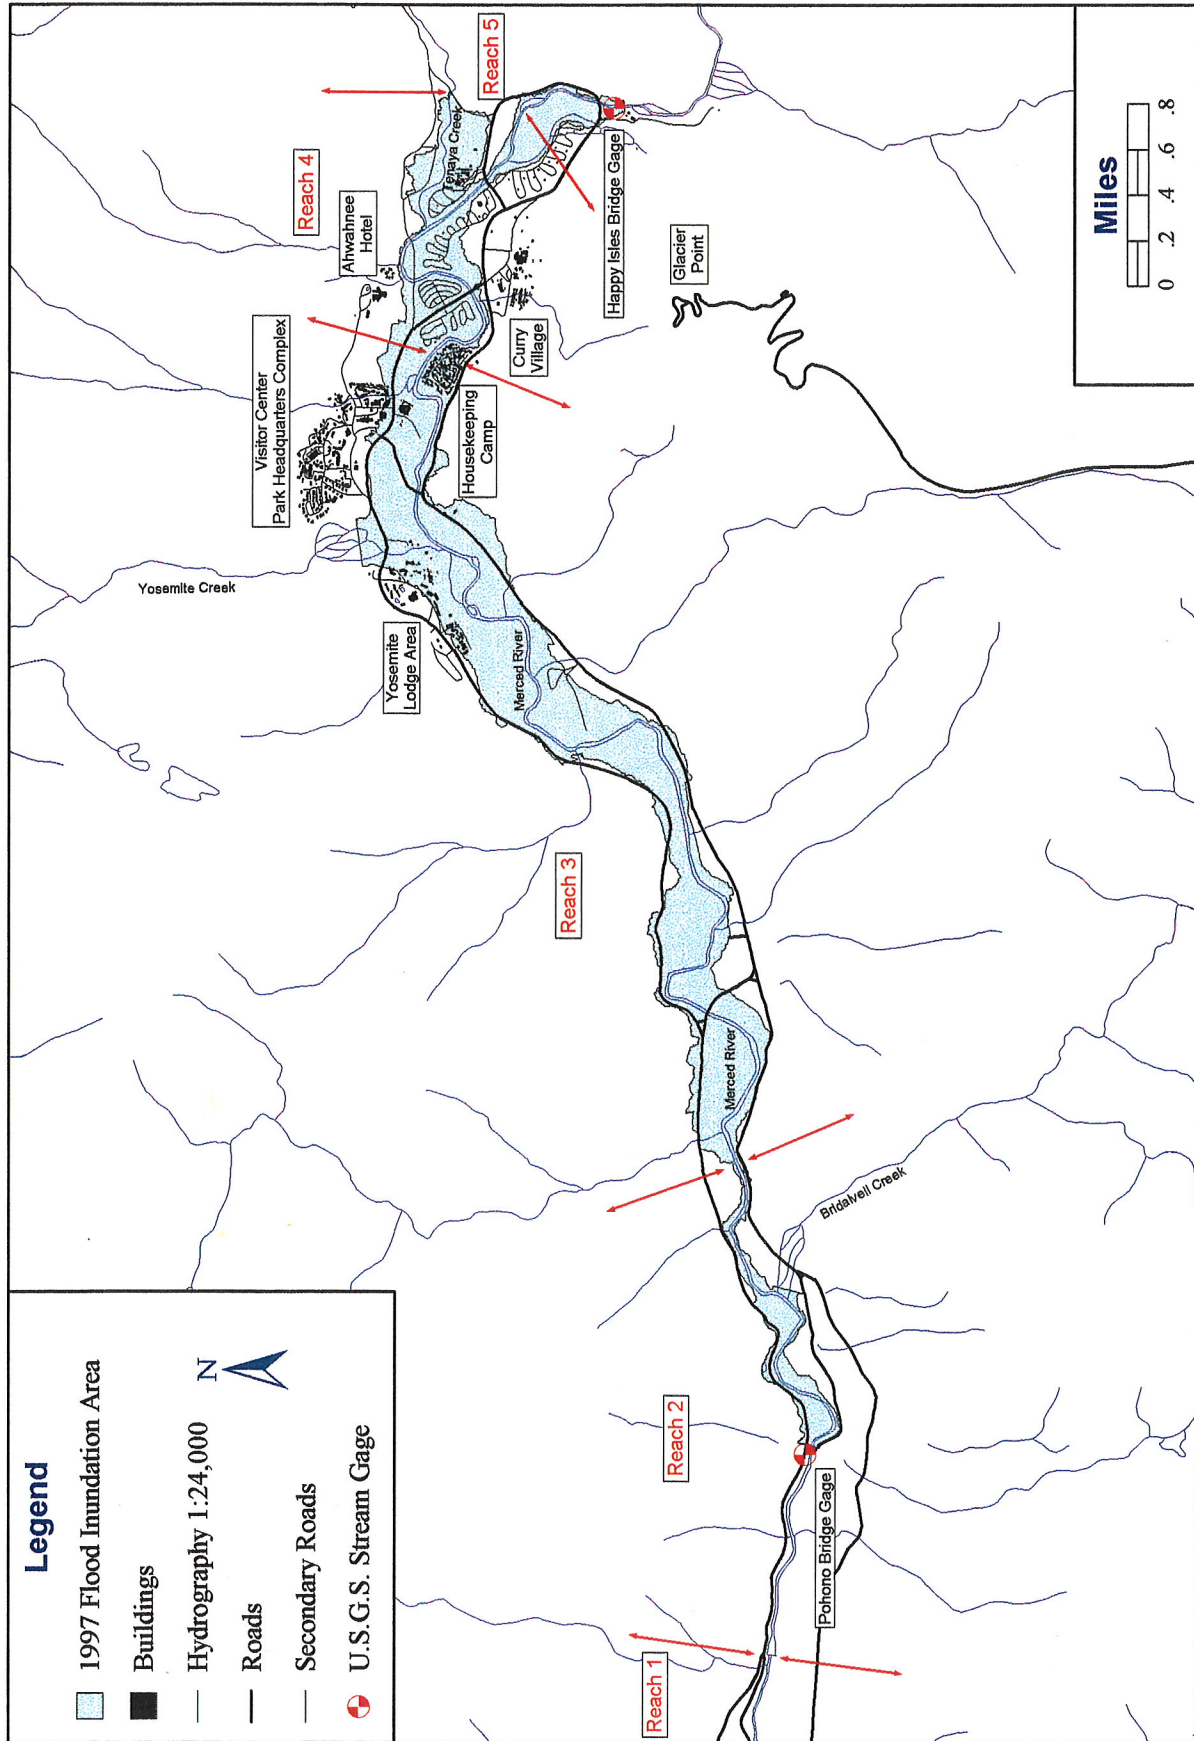
FIGURE 4. MAP DELINEATING FIVE GEOMORPHIC REACHES ALONG THE MERCED RIVER.

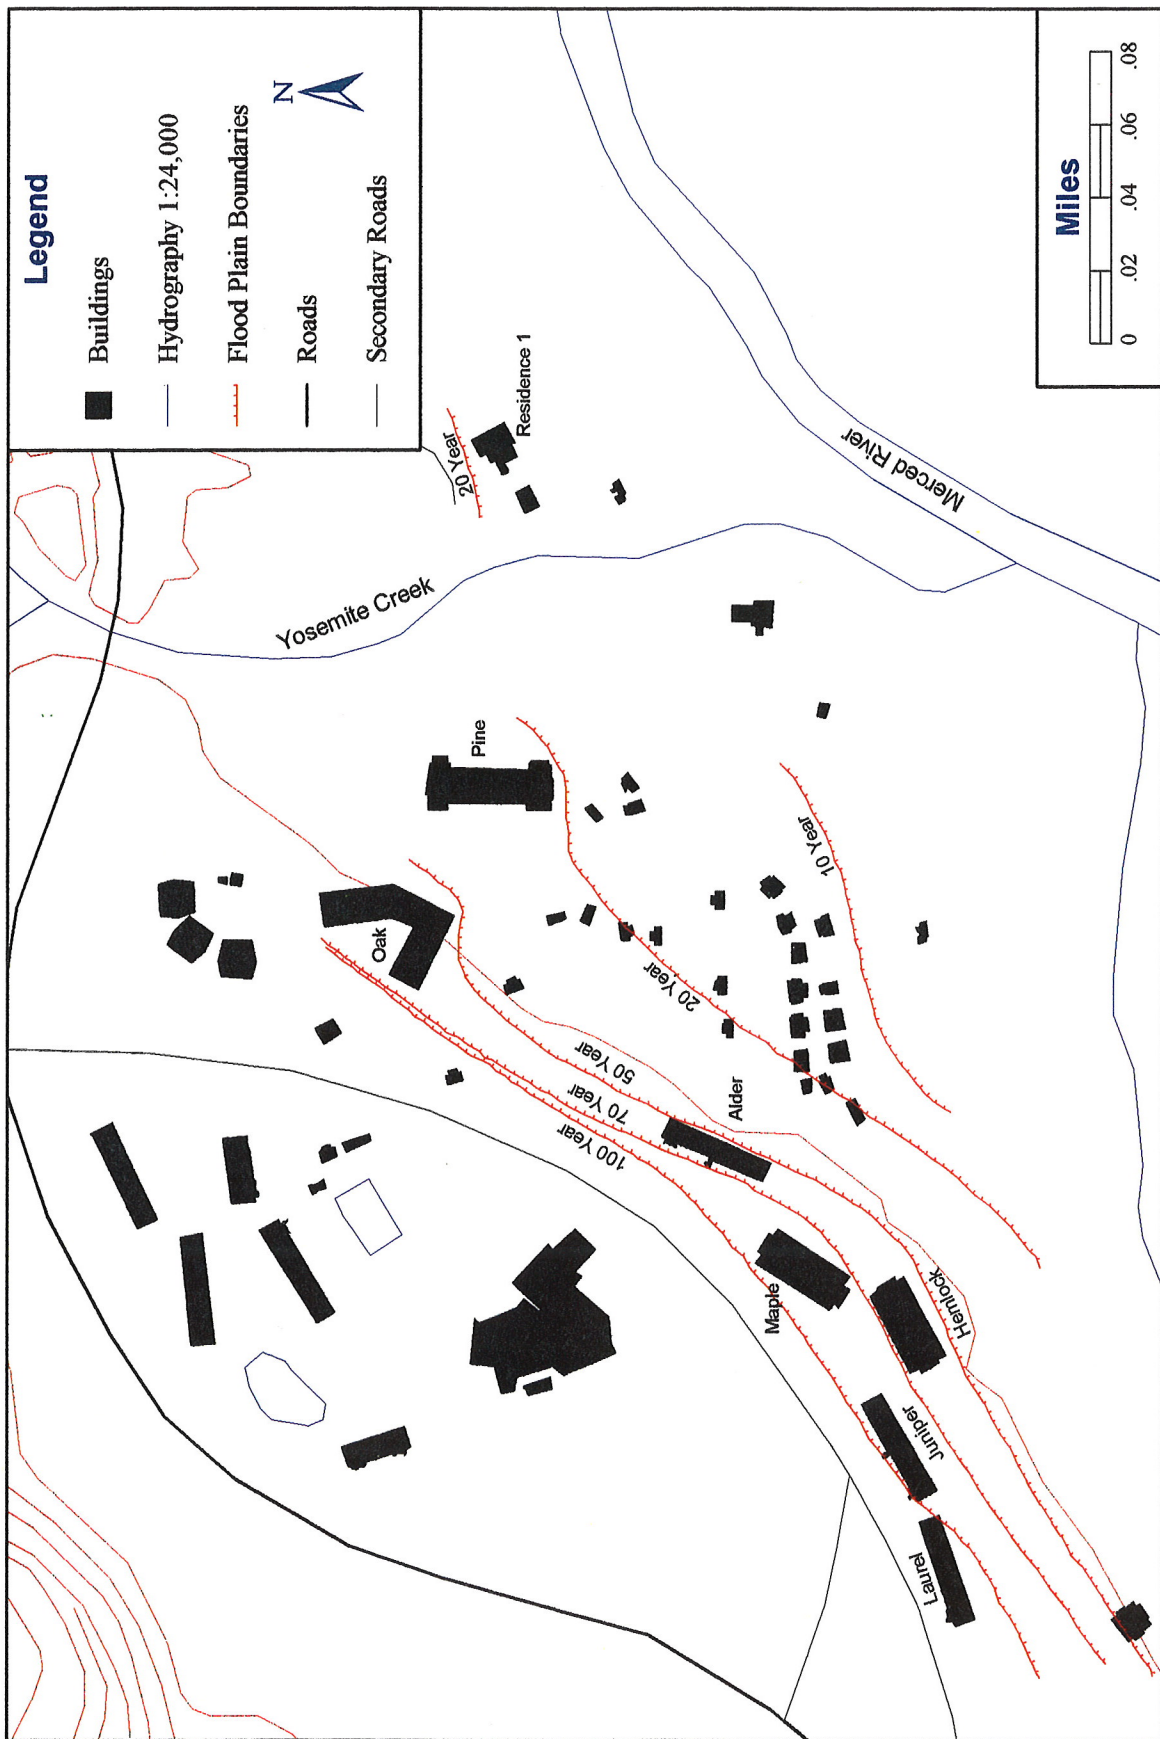
Using this relationship, individual structures were assigned a flood frequency based on the depth of flooding during this event. When all of the structures were tabulated, approximate floodplain boundaries were drafted on a base map using lodge units and their associated flood frequency as delineation points (Figure 12). From this map it is possible to estimate the frequency that particular areas of the lodge will be flooded. However, it is important to note that not all of the structures located in the lodge area are depicted on the base map. The area most prone to flooding is the "cabin without baths" section which is not shown on the base map. This area is located roughly due south of the Laurel and Juniper Cottages and contains at least 4 units located in the approximate 2-year floodplain, an additional 13 units in the 5-year floodplain, and as many as 25 units in the 10-year floodplain. Two additional areas associated with Yosemite Lodge but used as concessionaire employee housing are the Annex Cabin area and Camp Clark. Both of these areas experienced substantial flooding during the event and should be considered flood-prone. An example of the depth of flow experienced during the January 1997 flood in this area is shown in Figure 13. Flood depths in Camp Clark were in excess of 7 feet or roughly within the 30-year floodplain. The Annex Cabin area was subjected to flood depths that ranged from 4.7 to 5.6 feet, which corresponds roughly to the 50-year floodplain.

FIGURE 12. CLOSE UP MAP OF THE YOSEMITE LODGE AREA SHOWING APPROXIMATE FLOODPLAIN BOUNDARIES WITH ASSOCIATED FREQUENCIES.

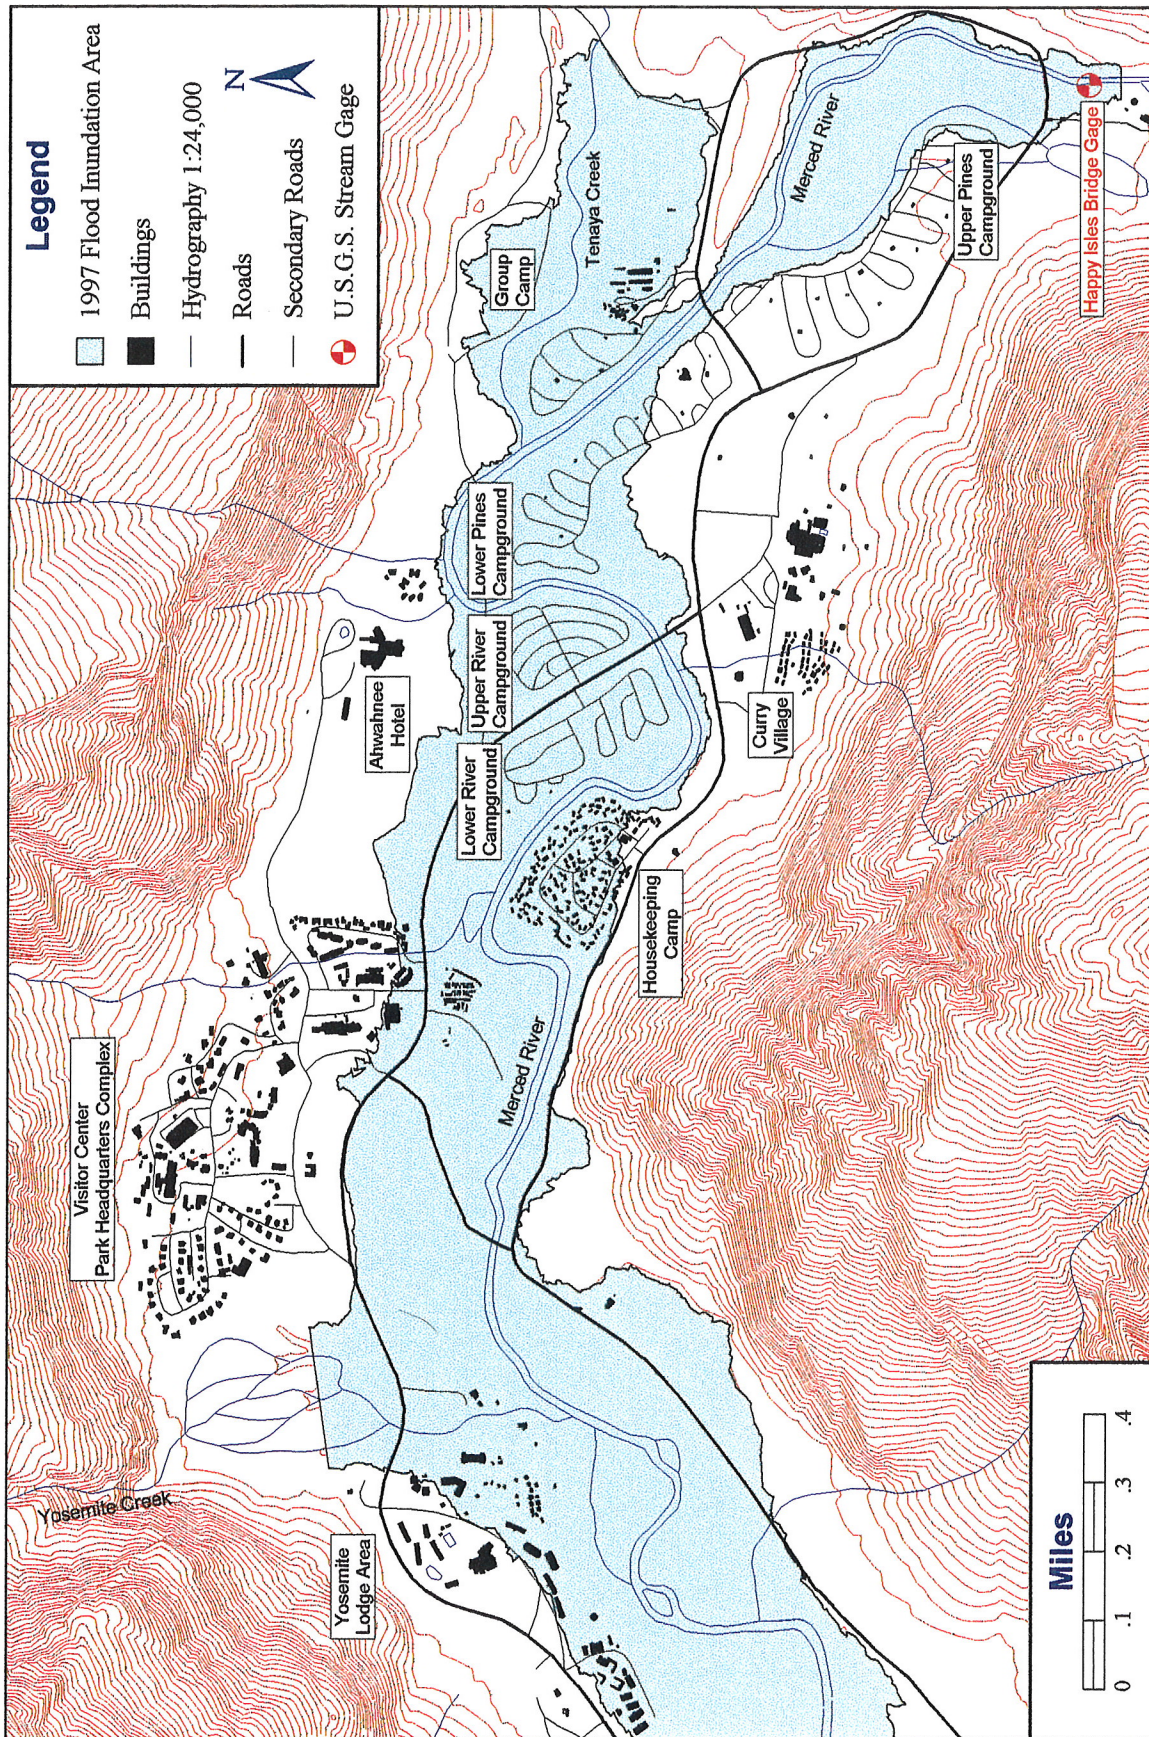
Almost the entire Yosemite Valley is a natural floodplain. A useful thing about this flood is that it permits an accurate delineation of the 100-year floodplain (the floodplain criteria most often used in planning activities). This is especially useful in areas where park infrastructure is concentrated (Figure 14). It will be virtually impossible for all park infrastructure to be located outside the floodplain. The issue in Yosemite Valley is how best to occupy the floodplain in a way which minimizes impacts to park resources and the risk to infrastructure. In this regard, there are some important lessons to be learned from this flood.

FIGURE 14. THE 100-YEAR FLOODPLAIN IN THE AREA OF CONCENTRATED PARK DEVELOPMENT, AS DETERMINED FROM THE 1997 FLOOD.
